**TECHNICAL MEMORANDUM**

**SARPY COUNTY SEWER INSPECTION**  
Calendar Year 2008

**SARPY COUNTY, NEBRASKA**

**WLA Project No. 149-005**

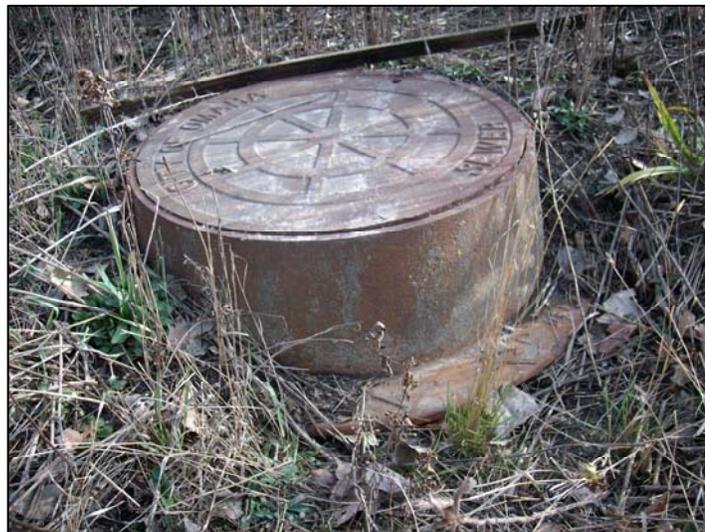
Manhole 72500-7  
Date: November 17, 2008

**Manhole ID:** 72500-7

**Severity:** Minor

**Observations:** Erosion under Manhole Ring.

**Recommendation:** Monitor for Progression of Erosion.

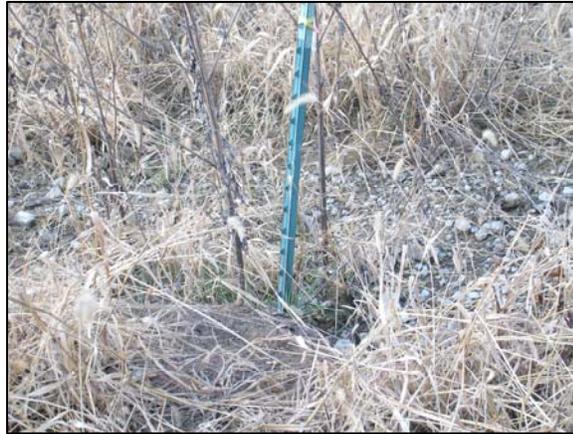
**Severity:** Major

**Observations:** Manhole 72500-8 is buried. Large amount of erosion taking place between top of hill and the sewer line. Reinforcement fabric has been placed along the hillside to slow the erosion. Northeast of Manhole 72500-9 significant erosion has occurred and is traveling toward sewer line.

Approximate location of Manhole 72500-8

**Recommendation:** Continue to monitor erosion. If erosion accelerates, the washed out area should be repaired.

Pink Industrial Park: Manholes 72500-01 through 72500-09 known as the Pink Industrial Park sewer are still buried due to erosion. It is recommended that Sarpy County request that these manholes be raised.

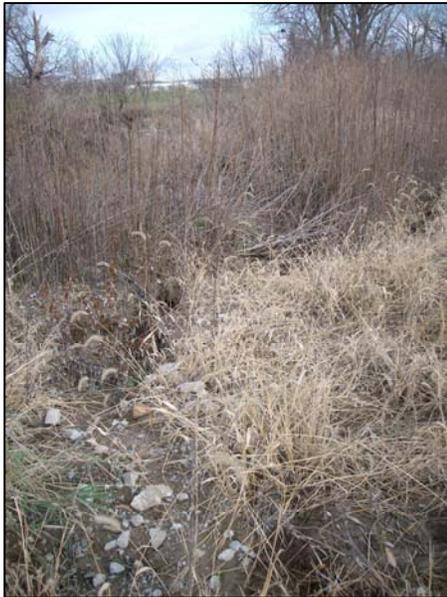
Erosion occurring Northeast of Manhole 72500-9

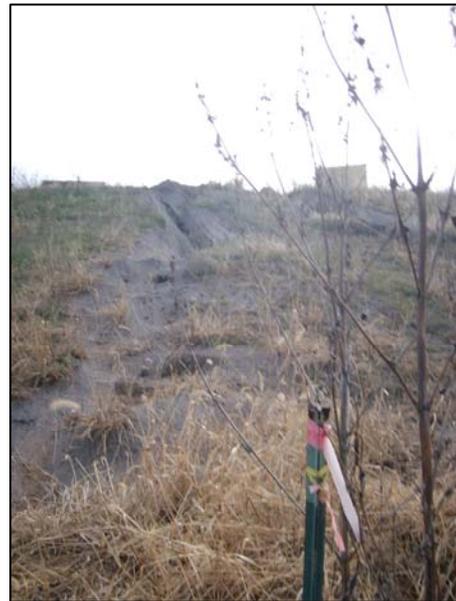
Erosion occurring uphill of Manhole 72500-9

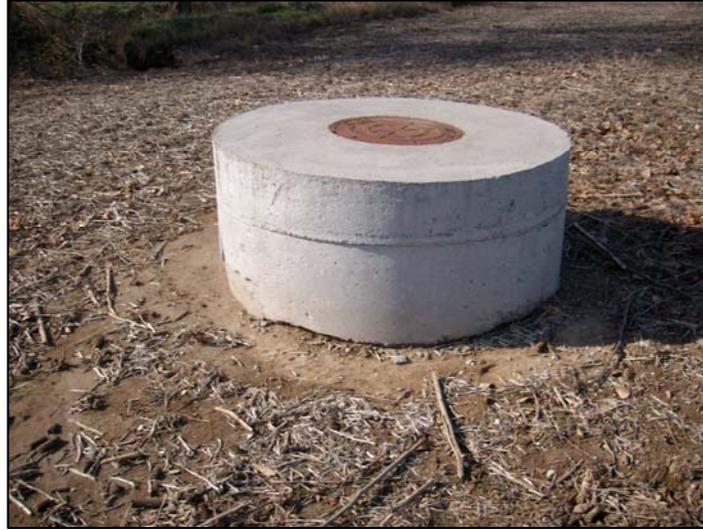
Manhole 32599-2  
Date: November 17, 2008

**Manhole ID:** 32599-2

**Severity:** Minor

**Observations:** Erosion around Concrete Collar of Manhole.

**Recommendation:** Monitor for Progression of Erosion.

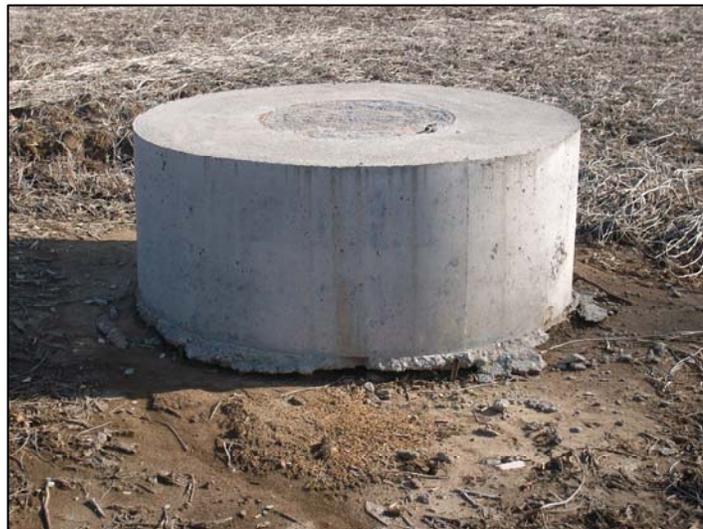
Manhole 32599-3  
Date: November 17, 2008

**Manhole ID:** 32599-3

**Severity:** Minor

**Observations:** Erosion around Concrete Collar of Manhole.

**Recommendation:** Monitor for Progression of Erosion.

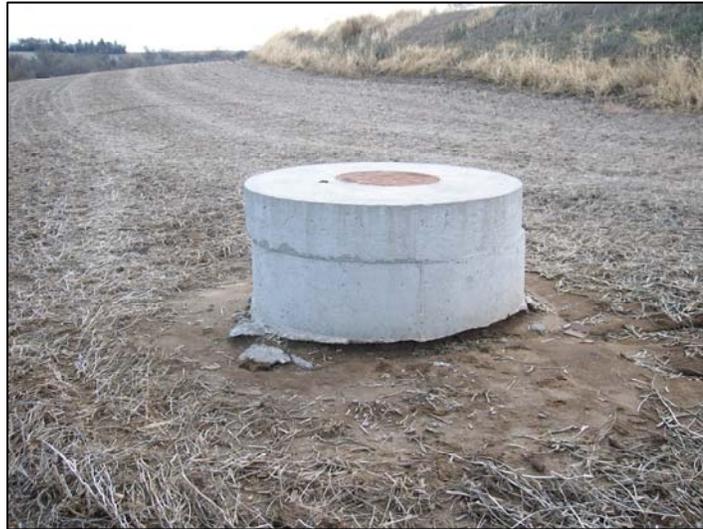
Manhole 32599-5

**Manhole ID:** 32599-5

**Severity:** Minor

**Observations:** Erosion around Concrete Collar of Manhole.

**Recommendation:** Monitor for Progression of Erosion.

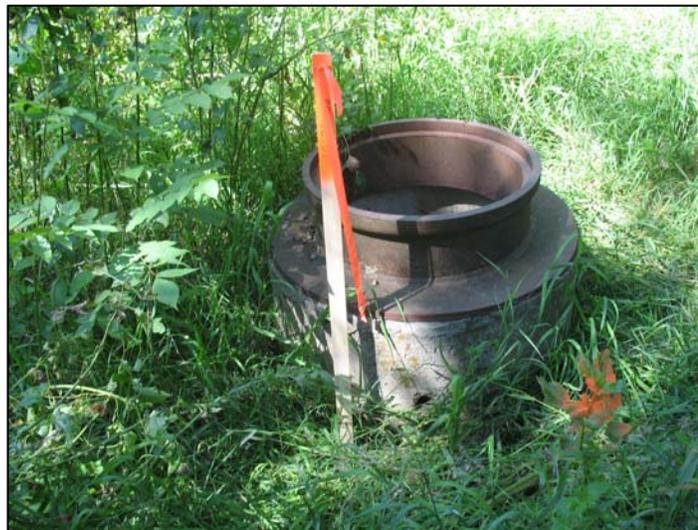
Manhole 10173-36

**Manhole ID:** 10173-36

**Severity:** Major

**Observations:** Manhole filled with trash and debris. No cover present.

| OBSERVATION NOTES: M.H. Just South of creek, no flow,<br>ring above grade, no collar, no cover. Needs attention<br>promptly. Full of debris, no observable influent pipe | | | |

**Recommendation:** Replace manhole cover. Remove debris.

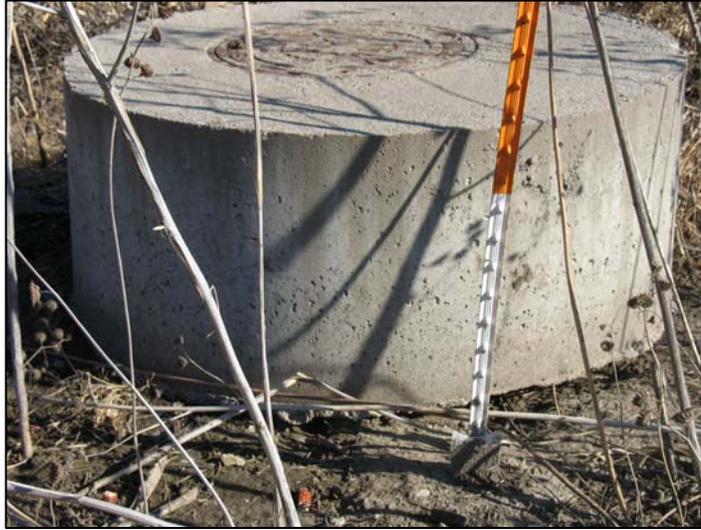
**Severity:** Minor

**Observations:** Erosion around concrete collar.

West side of Manhole 4896-53

**Recommendation:** Monitor for progression of erosion.

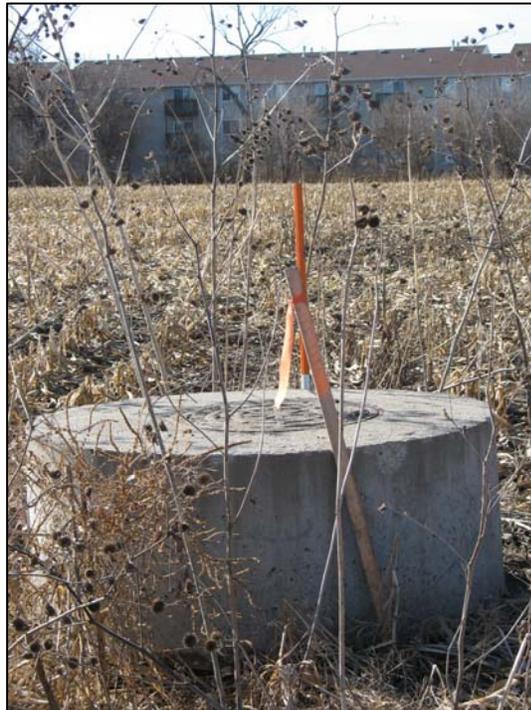
East side of Manhole 4896-53

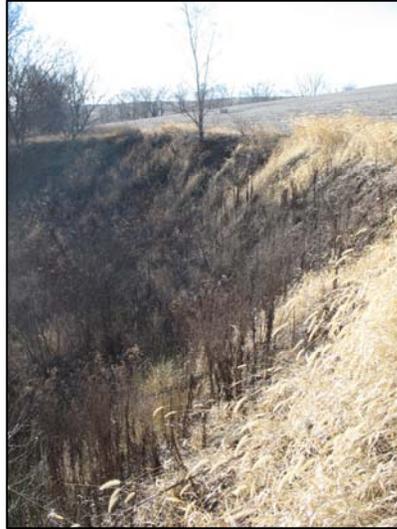
**Severity:** Major

**Observations:** Erosion between Manholes 10173-8 and 10173-9 has increased since 2007 inspection. Water flowing from the field to the creek is creating a large washout that continues to move toward the sewer line. If the erosion continues, the sanitary sewer line is endangered of being exposed.

Erosion occurring above creek bank

**Recommendation:** Continue to monitor erosion and if it worsens, the washed out area should be repaired.

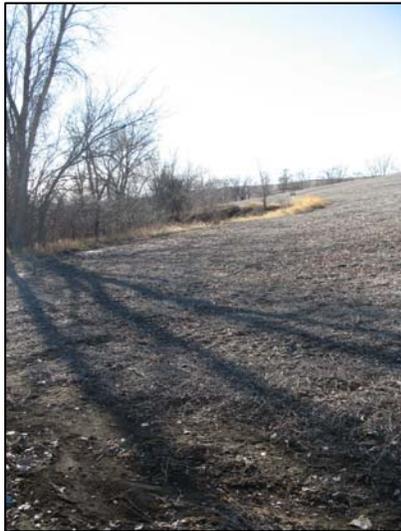
Looking at Manhole 10173-9 from  
Manhole 10173-8

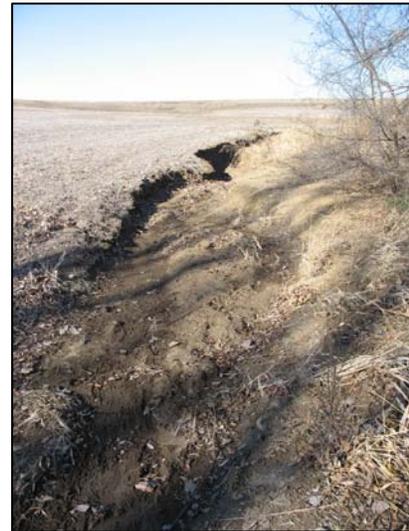
Erosion occurring uphill of  
Manhole 10173-8

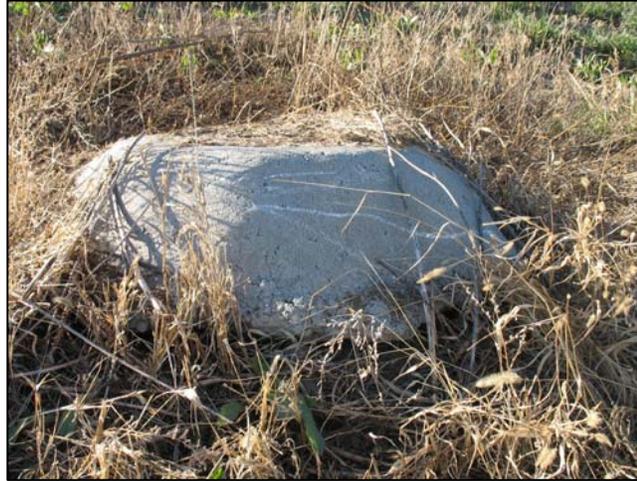
Manhole 22703-1

**Severity:** Minor

**Observations:** Erosion around Concrete Collar of Manholes.

**Recommendation:** Monitor for progression of erosion.

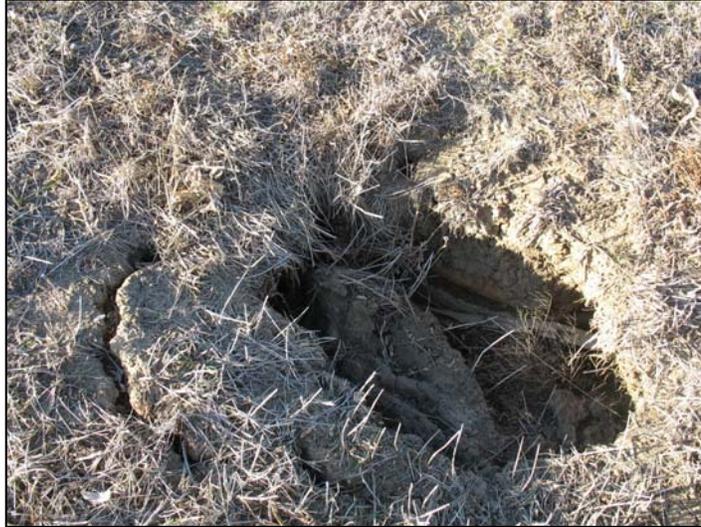
**Severity:** Minor

**Observations:** Manhole is buried. Large sink has occurred, exposing the manhole rim and collar.

Sink hole adjacent to Manhole 73097-1

**Recommendation:** Fill and seed sink hole. Reset Manhole Cover.

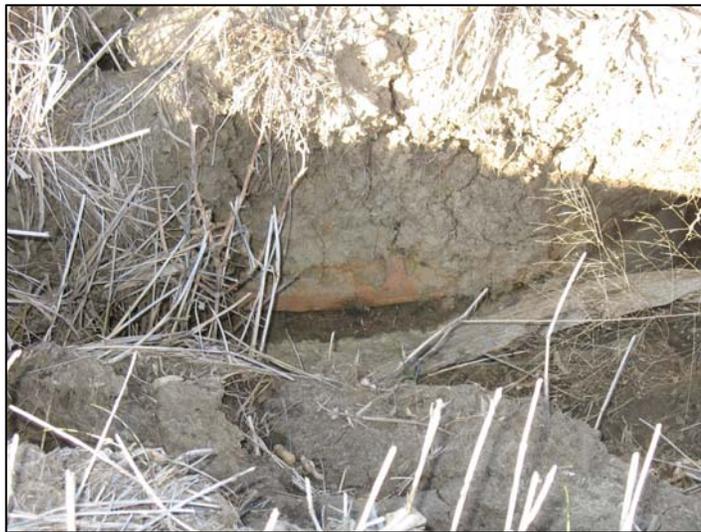
Exposed rim and collar of Manhole 73097-1
